**The NRC and
Nuclear Power
Plant Safety
in 2010:
A Brighter
Spotlight Needed**

DAVID LOCHBAUM

Union of Concerned Scientists
March 2011

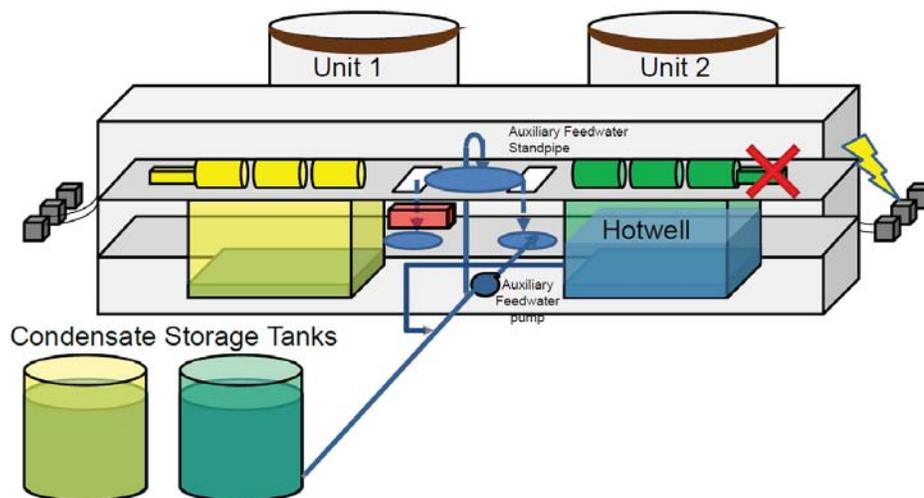
NRC drawing of the key components involved in the Braidwood near-miss. The red "X" indicates where the event started, when the main generator shut down.

However, the flow-control valve for one AFW pump failed in the open position, and the water level in the main condenser hotwell rose until valves opened to send some of this water back to the condensate tank. Nearly 12,000 gallons of water spilled onto the floor of the turbine building, from open standpipes installed on the piping between the outdoor tank and the AFW pumps (NRC 2010j).

Some of the spilled water flowed through holes in the floor and rained down on equipment on lower floors. Water leaked into an electrical panel housing controls for Unit 1 equipment. Two large pumps that circulate water between a nearby river and the main condenser stopped running because of electrical shorts. The reduction in cooling water flow through the main condenser impaired the condensation of steam inside the condenser. This impairment degraded the condenser's vacuum, triggering an automatic shut-down of the Unit 1 reactor about 15 minutes after the Unit 2 reactor shut down.

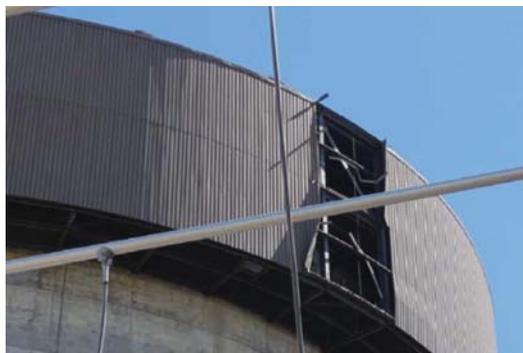
After the Unit 1 reactor shut down, the main steam safety valves (MSSVs) automatically opened to relieve pressure in the piping carrying steam from the steam generators to the main turbine. One MSSV stuck open after pressure dropped back below the opening set points. The operators did not realize that the MSSV was open until a worker arriving at the site 40 minutes later told them. Meanwhile steam passing through this open valve dislodged sheet-metal siding around the top of the Unit 1 containment building. Some of the siding landed on power lines for the Unit 1 off-site power transformer.

NRC photo of the metal siding torn from the containment building at the Braidwood nuclear power plant in Illinois.

The second violation involved failure to properly evaluate operating experience. Workers had evaluated an event at another nuclear plant where steam had dislodged metal siding, and had concluded that it did not apply to Braidwood. They failed to evaluate a previous event at Braidwood in which steam had dislodged metal siding. The NRC classified both violations as Green—the least serious of the color-coded violations.

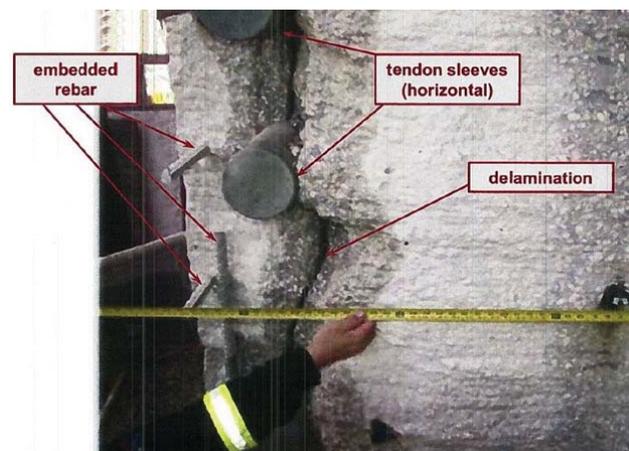
CR3's dome-shaped reactor containment structure is lined with a 3/8-inch layer of steel, reinforced with 282 horizontal 5-inch-thick metal cables, called tendons, and 144 ver-

NRC picture of the crack (delamination) in the concrete containment wall at Crystal River 3 caused when workers cut a square opening to replace the steam generators.

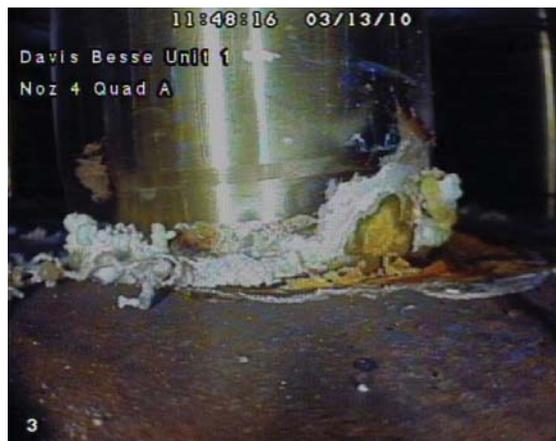
When workers performed Oconee-inspired inspections at Davis-Besse in March 2002, they found extensive cracking in the nozzles, and that leaking borated water had significantly degraded the reactor vessel head. Workers replaced this damaged head with one from the closed Midland nuclear plant in Michigan, and restarted Davis-Besse in March 2004. Inspections of the CRDM nozzles during refueling outages in 2006 and 2008 revealed no evidence of leakage.

White-crystalline boric acid leaked through a cracked nozzle in the head of the reactor vessel at the Davis-Besse plant in Ohio. NRC photo.

However, inspections during the March 2010 refueling outage revealed that two cracked CRDM nozzles had leaked borated reactor cooling water, and that many other nozzles had apparent cracks. Although the reactor vessel head did not need repair or replacement, workers repaired 24 of the 69 CRDM nozzles.

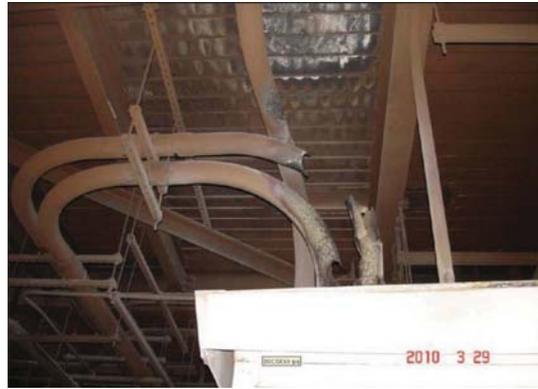
About four hours into the event, the operators attempted to restore power to the de-energized circuit, but they did not check first to ensure that workers had fixed the original fault—and they had not. When the operators closed the electrical breaker to repower the circuit, they reenergized the shorted cable, and it caused another fire. The electrical disturbance also triggered alarms on

Conduit for electrical cables damaged by the fire at the HB Robinson plant. NRC photo.

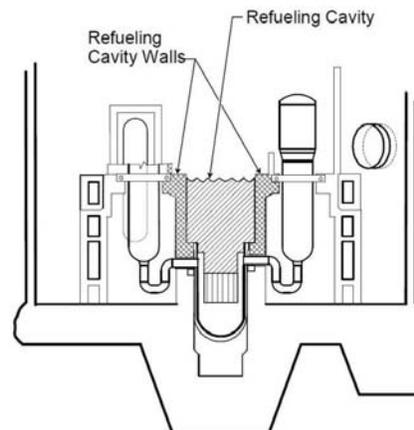
NRC drawing showing refueling cavity walls and the fuel rods located at the bottom of the cross-hatched refueling cavity volume.

However, NRC inspectors at Indian Point recently found that the liner has been leaking 2 to 20 gallons per minute since at least 1993 (NRC 2010v), and that the plant owner has not yet delivered on repeated promises to fix the leak. That means the device installed to prevent leakage after an earthquake is leaking before an earthquake even occurs. The liner has no other safety function. Yet NRC managers have dismissed the longstanding problem, noting that the refueling cavity leaks only when it is filled with water (NRC 2010o).

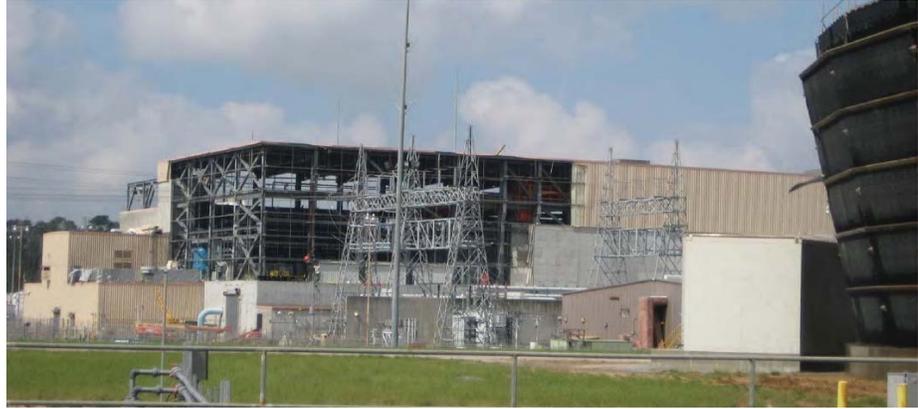
In September 2008, Hurricane Gustav caused considerable damage to the River Bend nuclear plant outside Baton Rouge, La. High winds tore sheet metal siding from three sides of the turbine building. The company repaired some damage and prepared to restart the reactor—planning to replace the walls of the turbine building later.

The turbine building at the River Bend plant after Hurricane Gustav removed its metal siding. NRC photo.
