The NRC and Nuclear Power Plant Safety in 2010

**The NRC and
Nuclear Power
Plant Safety
in 2010:
A Brighter
Spotlight Needed**

DAVID LOCHBAUM

Union of Concerned Scientists
March 2011

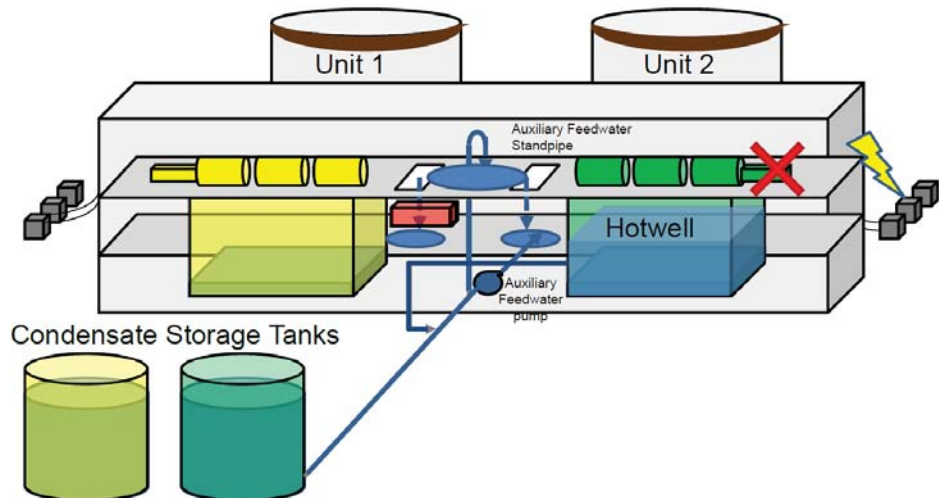
NRC drawing of the key components involved in the Braidwood near-miss. The red "X" indicates where the event started, when the main generator shut down.

However, the flow-control valve for one AFW pump failed in the open position, and the water level in the main condenser hotwell rose until valves opened to send some of this water back to the condensate tank. Nearly 12,000 gallons of water spilled onto the floor of the turbine building, from open standpipes installed on the piping between the outdoor tank and the AFW pumps (NRC 2010j).

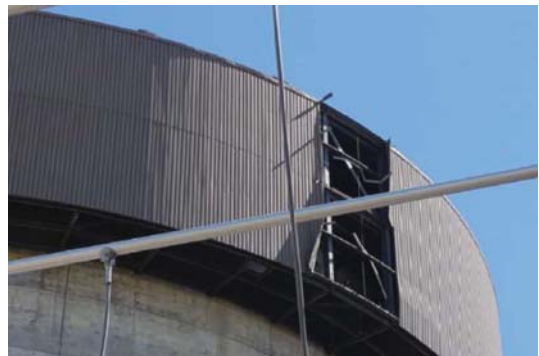
After the Unit 1 reactor shut down, the main steam safety valves (MSSVs) automatically opened to relieve pressure in the piping carrying steam from the steam generators to the main turbine. One MSSV stuck open after pressure dropped back below the opening set points. The operators did not realize that the MSSV was open until a worker arriving at the site 40 minutes later told them. Meanwhile steam passing through this open valve dislodged sheet-metal siding around the top of the Unit 1 containment building. Some of the siding landed on power lines for the Unit 1 off-site power transformer.

NRC photo of the metal siding torn from the containment building at the Braidwood nuclear power plant in Illinois.

The second violation involved failure to properly evaluate operating experience. Workers had evaluated an event at another nuclear plant where steam had dislodged metal siding, and had concluded that it did not apply to Braidwood. They failed to evaluate a previous event at Braidwood in which steam had dislodged metal siding. The NRC classified both violations as Green—the least serious of the color-coded violations.

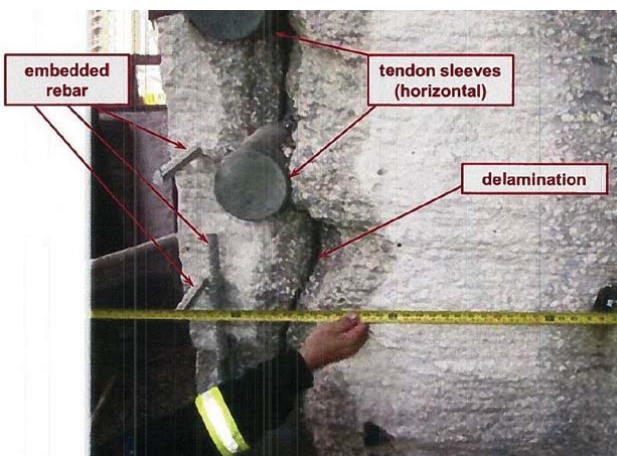
NRC picture of the crack (delamination) in the concrete containment wall at Crystal River 3 caused when workers cut a square opening to replace the steam generators.

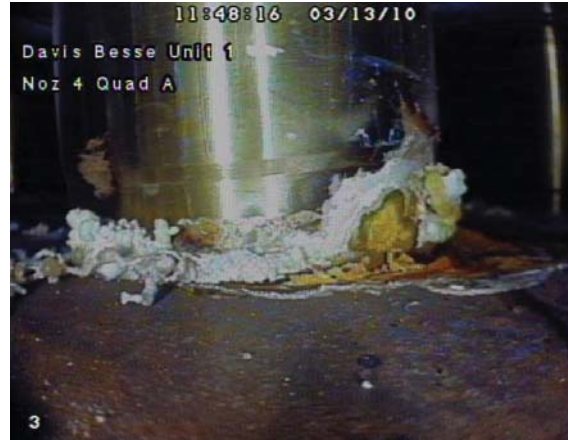
White-crystalline boric acid leaked through a cracked nozzle in the head of the reactor vessel at the Davis-Besse plant in Ohio. NRC photo.

However, inspections during the March 2010 refueling outage revealed that two cracked CRDM nozzles had leaked borated reactor cooling water, and that many other nozzles had apparent cracks. Although the reactor vessel head did not need repair or replacement, workers repaired 24 of the 69 CRDM nozzles.

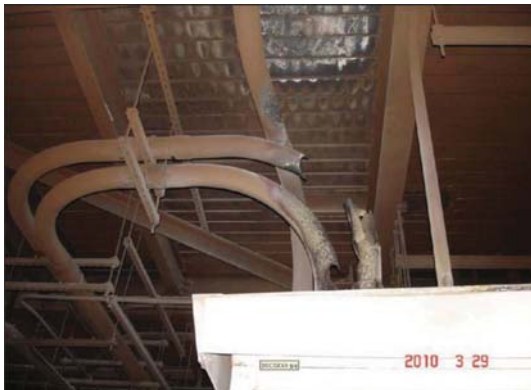
About four hours into the event, the operators attempted to restore power to the de-energized circuit, but they did not check first to ensure that workers had fixed the original fault—and they had not. When the operators closed the electrical breaker to repower the circuit, they reenergized the shorted cable, and it caused another fire. The electrical disturbance also triggered alarms on

Conduit for electrical cables damaged by the fire at the HB Robinson plant. NRC photo.

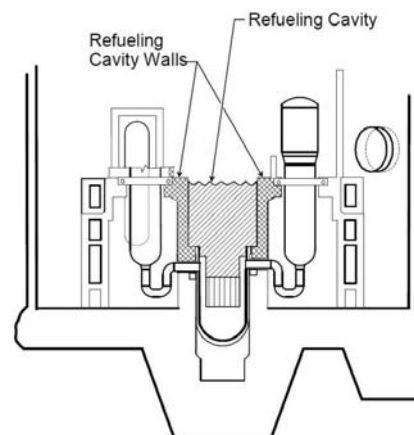
NRC drawing showing refueling cavity walls and the fuel rods located at the bottom of the cross-hatched refueling cavity volume.

However, NRC inspectors at Indian Point recently found that the liner has been leaking 2 to 20 gallons per minute since at least 1993 (NRC 2010v), and that the plant owner has not yet delivered on repeated promises to fix the leak. That means the device installed to prevent leakage after an earthquake is leaking before an earthquake even occurs. The liner has no other safety function. Yet NRC managers have dismissed the longstanding problem, noting that the refueling cavity leaks only when it is filled with water (NRC 2010o).

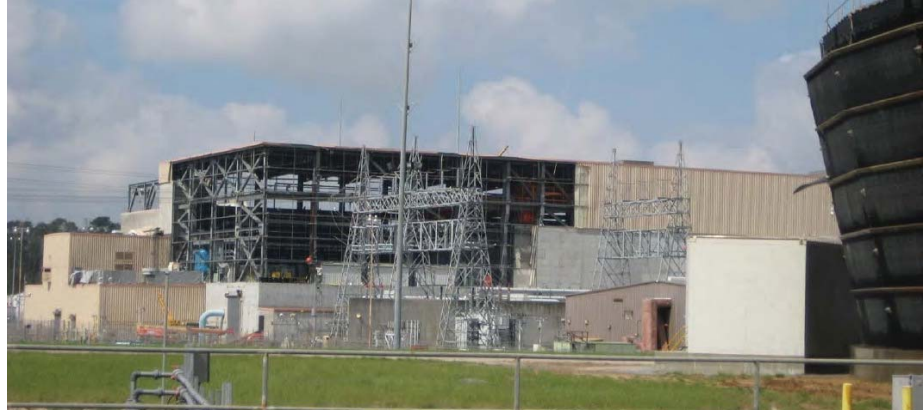
In September 2008, Hurricane Gustav caused considerable damage to the River Bend nuclear plant outside Baton Rouge, La. High winds tore sheet metal siding from three sides of the turbine building. The company repaired some damage and prepared to restart the reactor—planning to replace the walls of the turbine building later.

The turbine building at the River Bend plant after Hurricane Gustav removed its metal siding. NRC photo.
