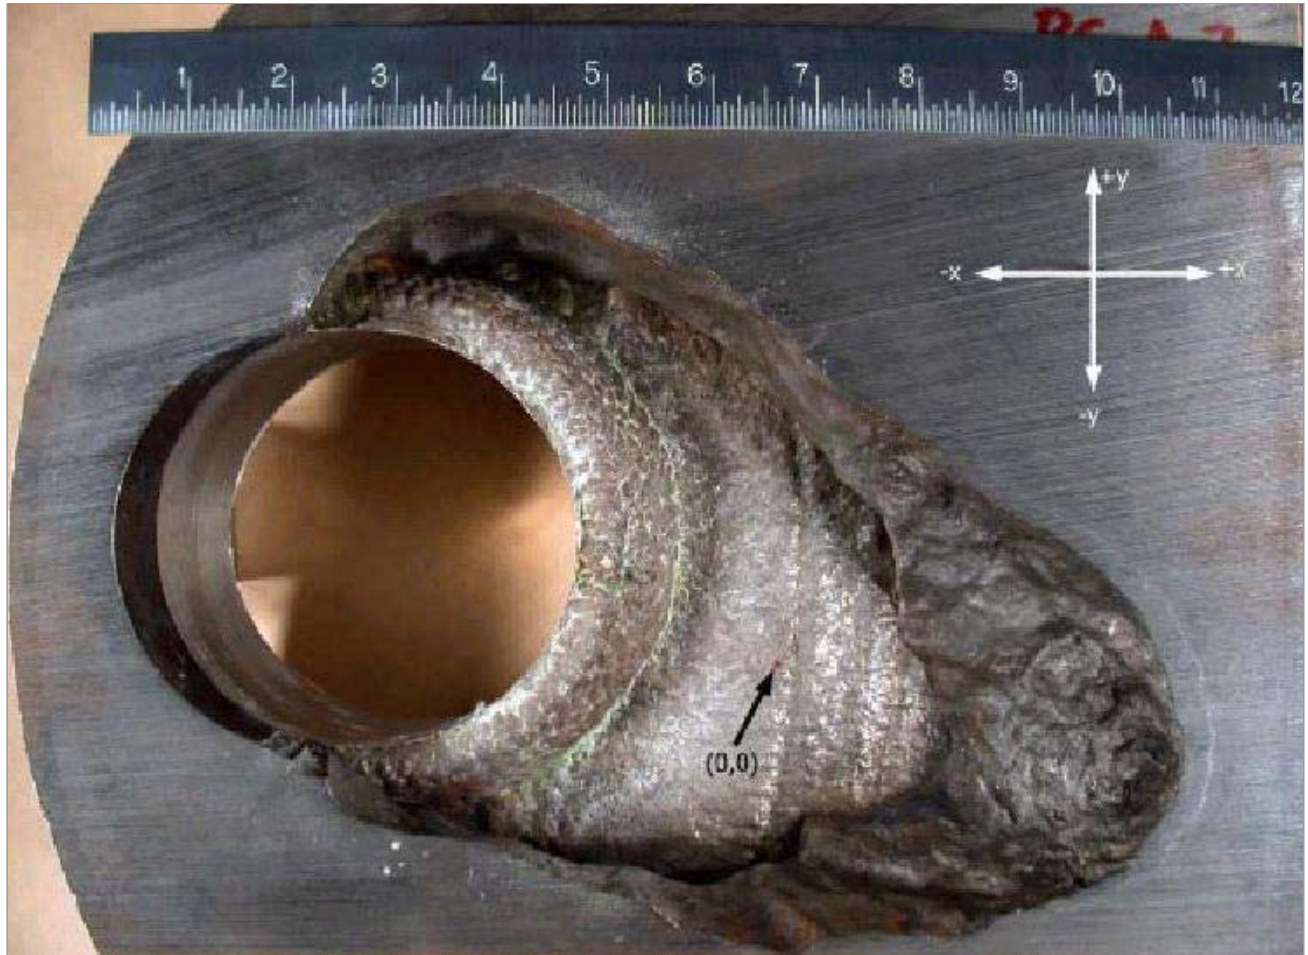
This undated photo made available by the Nuclear Regulatory Commission shows a 5-by-5-inch hole in a section cut from the top of the reactor vessel at the Davis-Besse nuclear plant in Ohio. Discovered in February 2002, the hole was eaten by boric acid that spilled from inside the reactor through cracks in the vessel head. Only three-eighths of an inch of steel cladding remained, making a reactor breach likely in as little as two months, by the NRC's estimate. (AP Photo/Nuclear Regulatory Commission)
