Status of the Nuclear Reactors at the Fukushima Daiichi Power Plant

None of the six reactors at the plant have operated since the earthquake. But explosions have damaged four of the buildings, and fuel in the reactors and spent fuel stored in the buildings is in danger of melting and releasing radioactive materials. Last updated on March 31, 3.30 p.m. EDT. All reactor status updates are listed in Japan time.

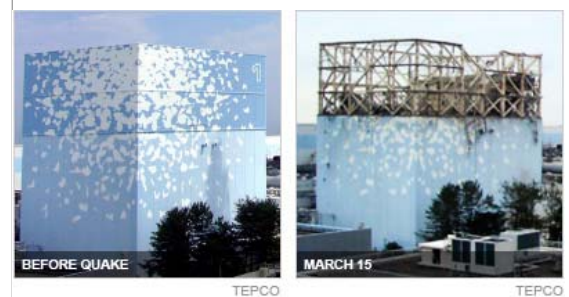
[Show More Updates](#)
Outer building is damaged and it is presumed that there was a partial meltdown. Small amounts of radioactivity have been vented and some may have leaked. Operators have had trouble cooling down the reactor. The reactor has 400 fuel assemblies and the spent fuel pool has 292.
