## Flood wall fails at Fort Calhoun

By Sam Womack  
WORLD-HERALD STAFF WRITER

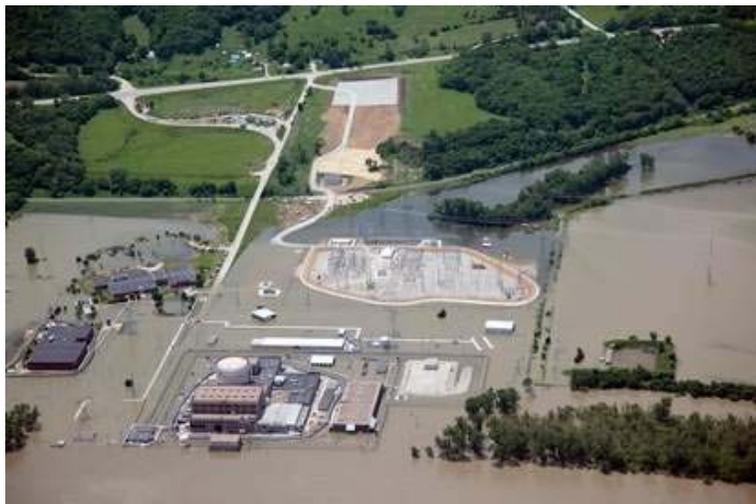
MATT MILLER/THE WORLD-HERALD

In this June 16, 2011, aerial photo the nuclear power plant at Fort Calhoun, Neb., is surrounded by water.
