Associated Press Picture & Information Slide Show June 20, 2011

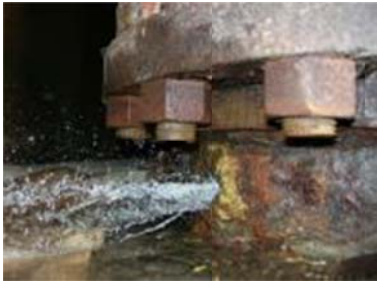
Photo 1 of 23

This photo made available by the Nuclear Regulatory Commission shows a 10-gallon-per-minute leak which sprung Oct. 19, 2007, in rusted piping that carried essential service water at the Byron nuclear plant in Illinois. The water is needed to cool the reactor in an emergency. The plant was immediately taken offline for repairs. Federal regulators have been working closely with the nuclear power industry to keep the nation's aging reactors operating within safety standards by repeatedly weakening those standards, or simply failing to enforce them, an investigation by The Associated Press has found. Time after time, officials at the U.S. Nuclear Regulatory Commission have decided that original regulations were too strict, arguing that safety margins could be eased without peril, according to records and interviews. (AP Photo/Nuclear Regulatory Commission)

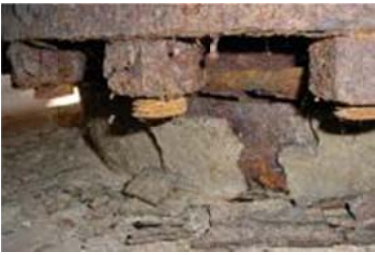
Photo 3 of 23

This June 14, 2007, photo made available by the Nuclear Regulatory Commission shows some of the extensive rust that accumulated on piping carrying essential service water at the Byron nuclear plant in Illinois. The water is needed to cool the reactor in an emergency. A leak in the system forced the plant to go offline for repairs later that year. (AP Photo/Nuclear Regulatory Commission)

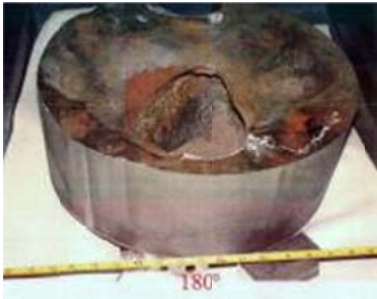
Photo 5 of 23

This undated photo made available by the Nuclear Regulatory Commission shows a 5-by-5-inch hole in a section cut from the top of the reactor vessel at the Davis-Besse nuclear plant in Ohio. Discovered in February 2002, the hole was eaten by boric acid that spilled from inside the reactor through cracks in the vessel head. Only three-eighths of an inch of steel cladding remained, making a reactor breach likely in as little as two months, by the NRC's estimate. (AP Photo/Nuclear Regulatory Commission)

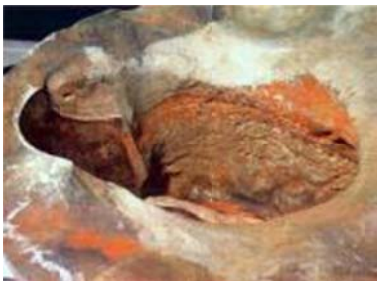
Photo 6 of 23

This undated photo made available by the Nuclear Regulatory Commission shows a 5-by-5-inch hole in a section cut from the top of the reactor vessel at the Davis-Besse nuclear plant in Ohio. Discovered in February 2002, the hole was eaten by boric acid that spilled from inside the reactor through cracks in the vessel head. Only three-eighths of an inch of steel cladding remained, making a reactor breach likely in as little as two months, by the NRC's estimate. (AP Photo/Nuclear Regulatory Commission)

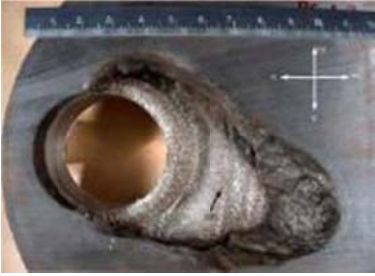
Photo 7 of 23

This undated photo made available by the Nuclear Regulatory Commission shows a 5-by-5-inch hole in a section cut from the top of the reactor vessel at the Davis-Besse nuclear plant in Ohio. Discovered in February 2002, the hole was eaten by boric acid that spilled from inside the reactor through cracks in the vessel head. Only three-eighths of an inch of steel cladding remained, making a reactor breach likely in as little as two months, by the NRC's estimate. (AP Photo/Nuclear Regulatory Commission)

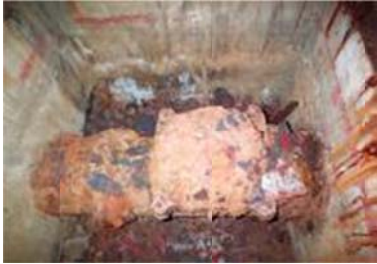
Photo 10 of 23

This July 2007 photo made available by the Nuclear Regulatory Commission in response to a public records request by The Associated Press shows a badly rusted valve inside a vault at the closed Indian Point 1 nuclear plant in New York state. The pipe was part of a containment spraying system that was initially a focus of concern as workers tried to find the source of leaks at the site. The leakage was eventually traced to spent fuel pools. The reactor had been shut down since 1974. (AP Photo/Nuclear Regulatory Commission)

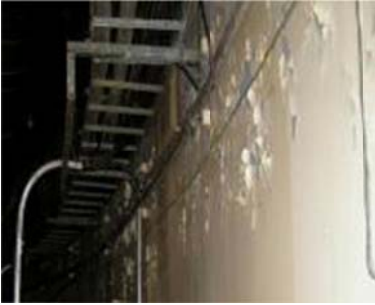
Photo 14 of 23

This spring 2004 photo made available by the Nuclear Regulatory Commission shows the finish peeling off a wall at the Oconee nuclear plant in South Carolina. An NRC inspector general's report in September 2007 said the operator had failed to manage this aging problem as it promised during relicensing. Even mundane deterioration at a reactor can carry harsh consequences. For example, peeling paint and debris can be swept toward pumps that circulate cooling water in a reactor accident. (AP Photo/Nuclear Regulatory Commission)
